DRESSER NO. 1 DAM  
WASHINGTON COUNTY, MISSOURI  
MO 31117

**PHASE I INSPECTION REPORT  
NATIONAL DAM SAFETY PROGRAM**

DRESSER NO. 1 DAM  
WASHINGTON COUNTY, MISSOURI

PHASE I INSPECTION REPORT  
NATIONAL DAM SAFETY PROGRAM

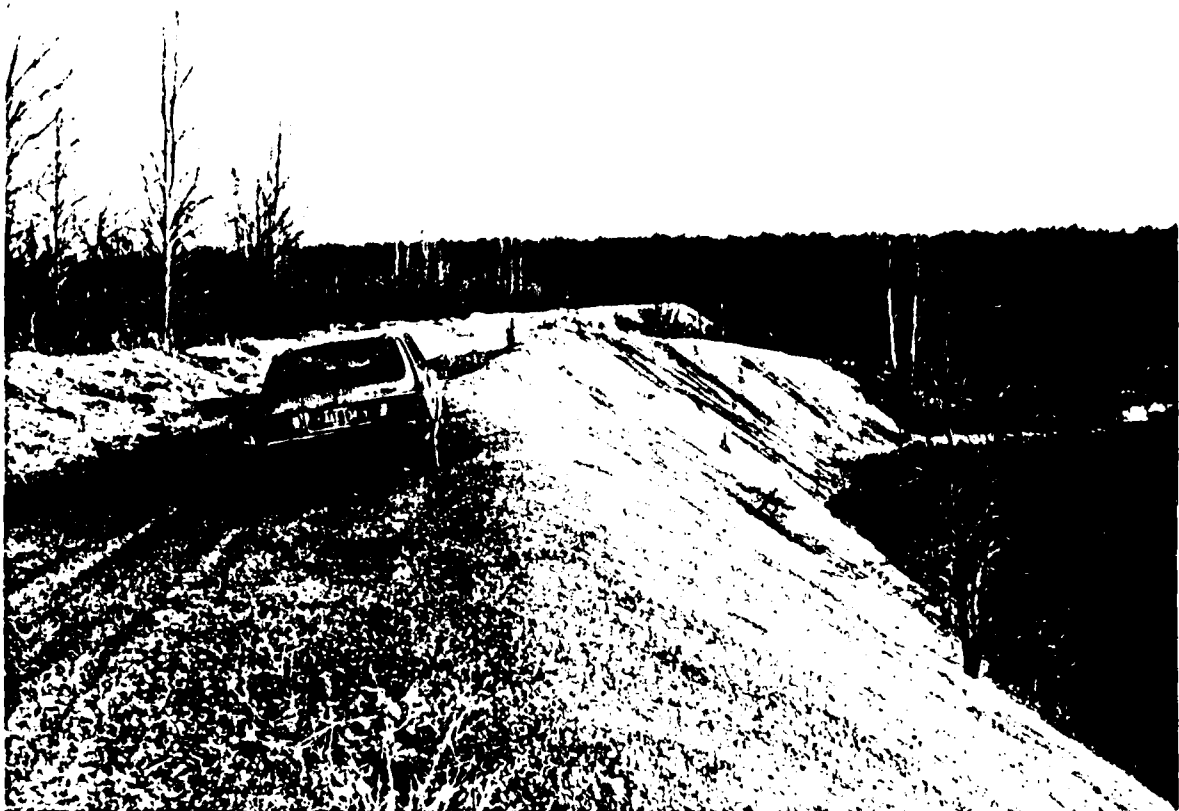
OVERVIEW OF THE EAST END OF THE TAILINGS  
IMPOUNDMENT OF DRESSER NO. 1 DAM AND DOWNSTREAM POND
